F-111 Bonded Panel Repair Status

DSTO-TR-0803

**Maritime Platforms Division
Aeronautical and Maritime Research Laboratory**

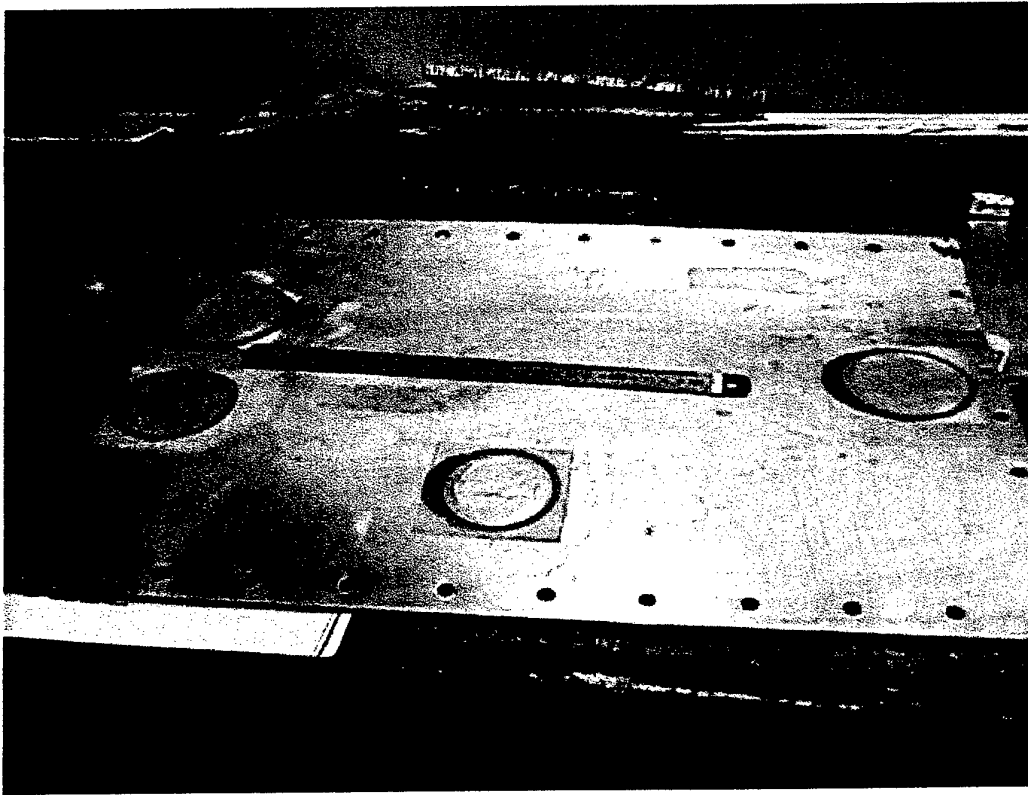
The first case in which this problem arises is when honeycomb panels with pre-existing injection repairs have a metal patch applied. The Engineering Standard C5033 indicates that a metal patch should be placed over existing injection repairs after NDI inspection and moisture removal. This procedure is conducted to provide environmental protection and structural strength to the honeycomb panel. Typically a tap test identifies the damaged region and skin is removed from this area. If the core is intact then moisture removal is undertaken and a patch is applied. In some instances further damage to the panel occurs during drying of the panel at 110°C. This damage is caused by steam pressurisation. Figures 1 and 2, however, provide a good example of the extent of the damage that occurs during the vacuum bag curing of the FM-300 adhesive when the structural metal patch is bonded.

Figure 1.0 Structural metal patches bonded over injection repair areas of a honeycomb panel. Patches bonded at 160°C using FM-300. The ruler is 350mm long.

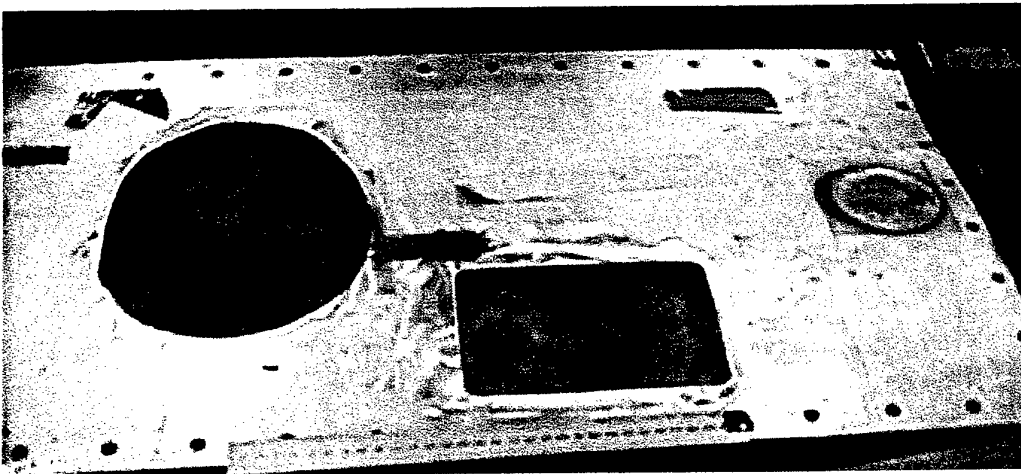
Figure 2.0. The areas that had to be routed from the panel in Figure 1.0 as a result of disbond failure occurring during the cure cycle of the adhesive required for the patch application to the pre-existing injection repairs. The ruler is 350mm long.

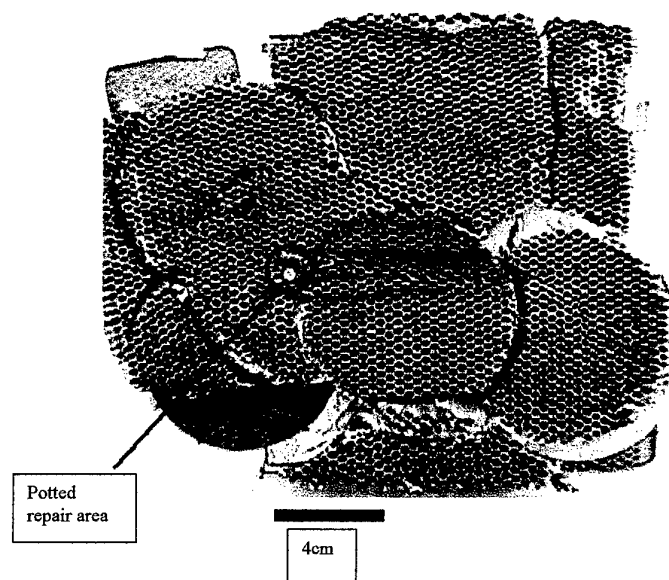
In the second example a potted repair was performed on an F-111 fuel tank. The initial repair involved riveting and potting a partially debonded patch as shown in figure 3. The damaged area was initially only 2cm in diameter. Subsequently, a series of holes were drilled for injection repairs to rebond the partially debonded patch, as shown in figure 4. A second patch to repair the rivet and potted repair in figure 3 was cut around the defective patch, thus reducing the required overlap length of the repair patch. The moisture removal procedure, refer section 4, extended the damage, leading to a full skin and core removal of approximately 25cm x 25cm. The repair shown is in figure 5. The repair requires a request for disposition/request for waiver(RFD/RFW).

Figure 3.0 The initial repair of an F-111 fuel tank. This involved riveting and potting a partially debonded patch. This area was initially only 2cm in diameter.

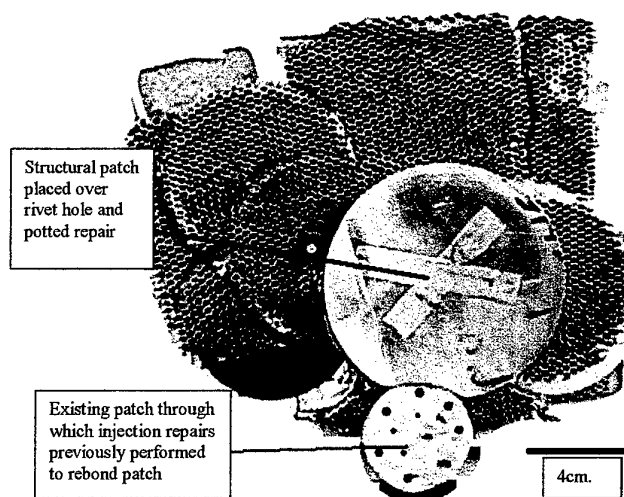
Figure 4.0 The second stage of the F-111 fuel tank repair. Injection repairs attempted to rebond the partially debonded patch. A second patch to repair the rivet and potted repair in Figure 3 was cut to fit around the defective patch, reducing the required overlap specified by the repair document.

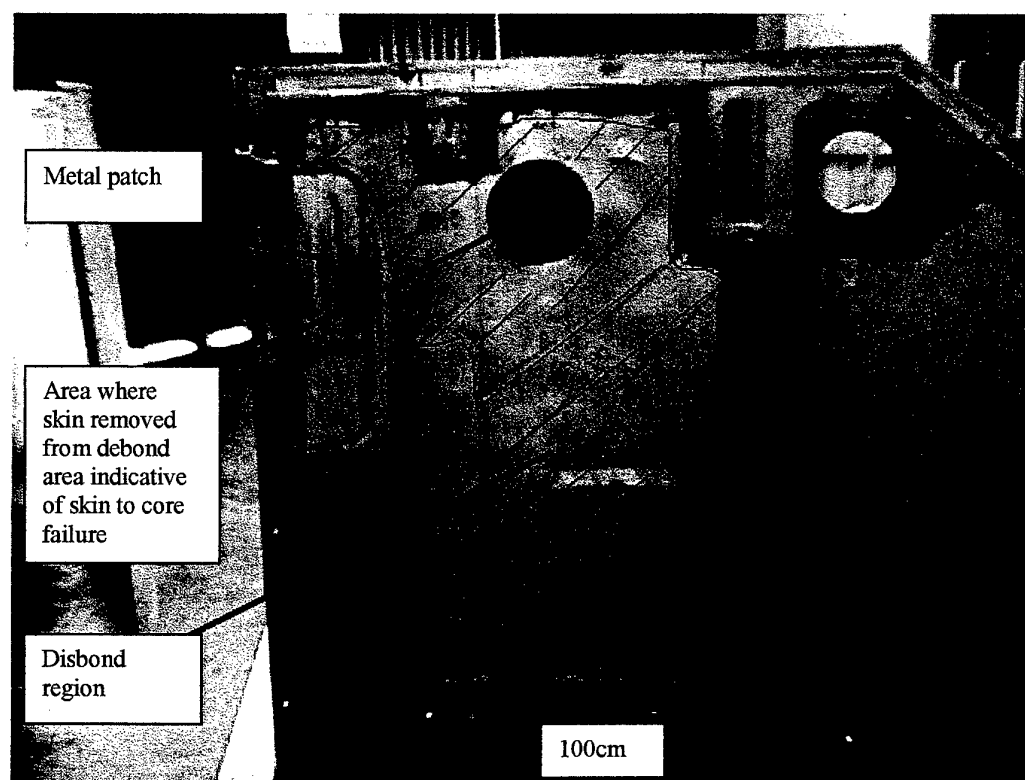
The previous examples of honeycomb repair dealt with honeycomb core material constructed from aluminium and core splice adhesive. However, some panels present on the F-111 were constructed from a phenolic core material. This honeycomb material is very susceptible to moisture absorption. Figure 6.0 displays a large honeycomb panel constructed from phenolic core material that was repaired by core removal followed by application of a metallic patch. The picture clearly indicates the size of the repair patch and the area of disbond as a result of applying the patch using FM-300 adhesive at a cure temperature of 160°C.

Figure 6.0 Damage to a phenolic honeycomb core panel resulting from the application of a structural metallic patch. Nearly half the panel is disbonded as a result of the internal pressure generated as moisture trapped in the panel vaporises during the adhesive cure cycle.

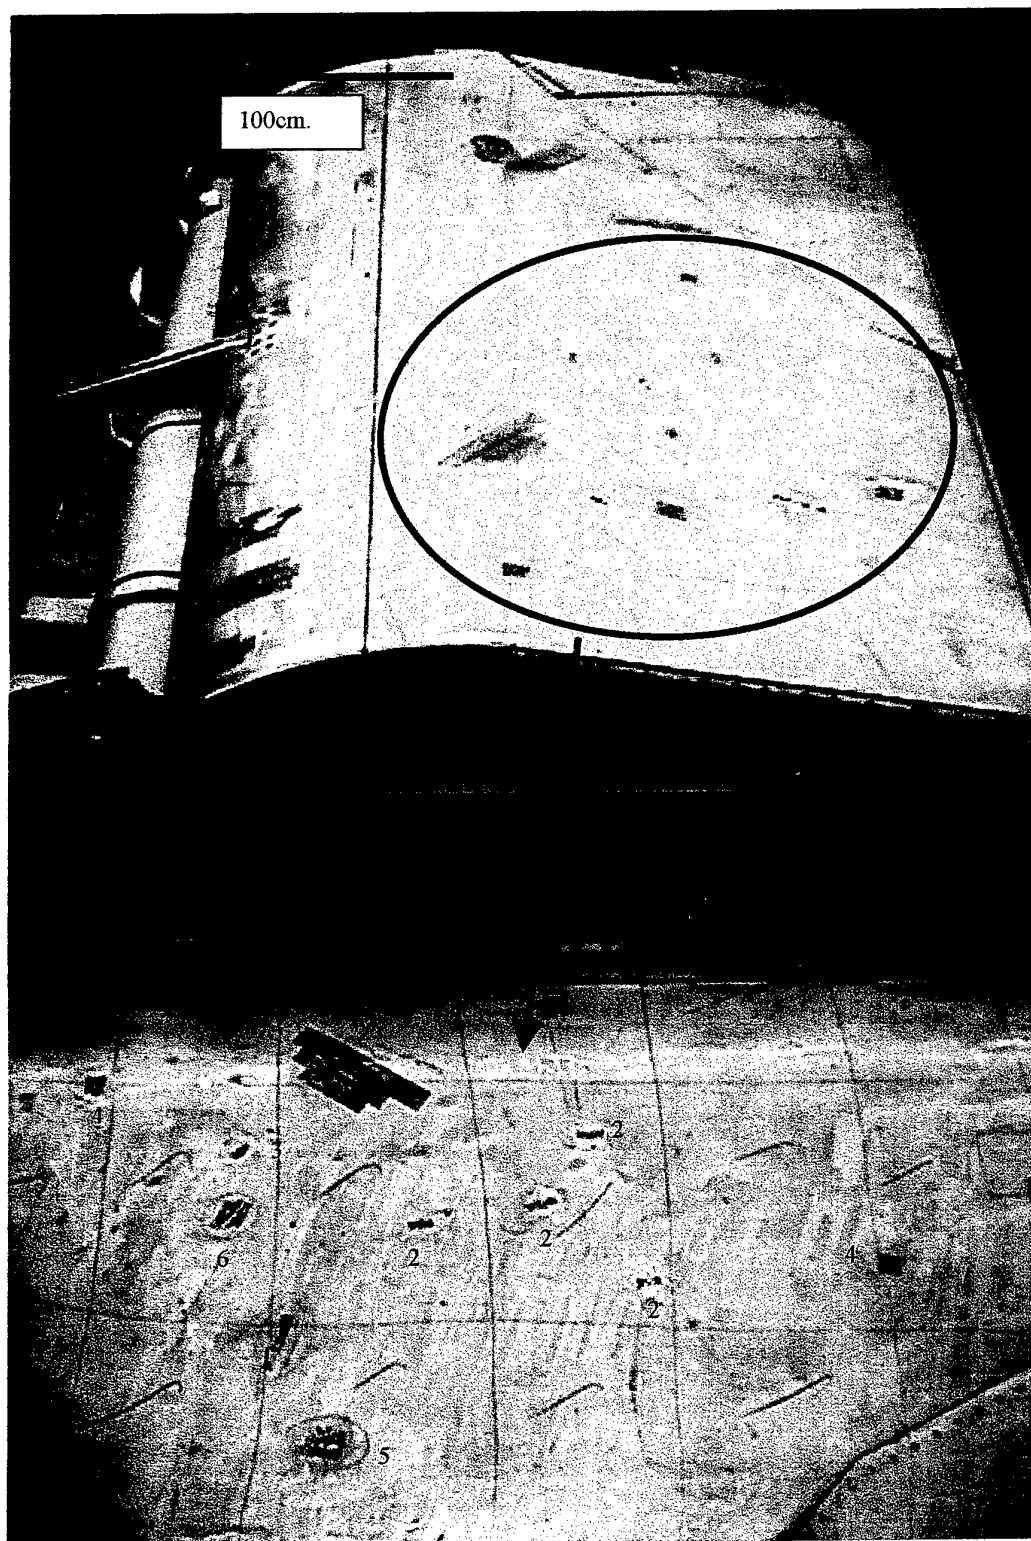
Figure 7.0 An example of the potential number of injection repairs, which may be associated with one F-111 honeycomb bonded component. Injection repair hole numbers are indicated. None of these repairs had been protected with a structural patch.

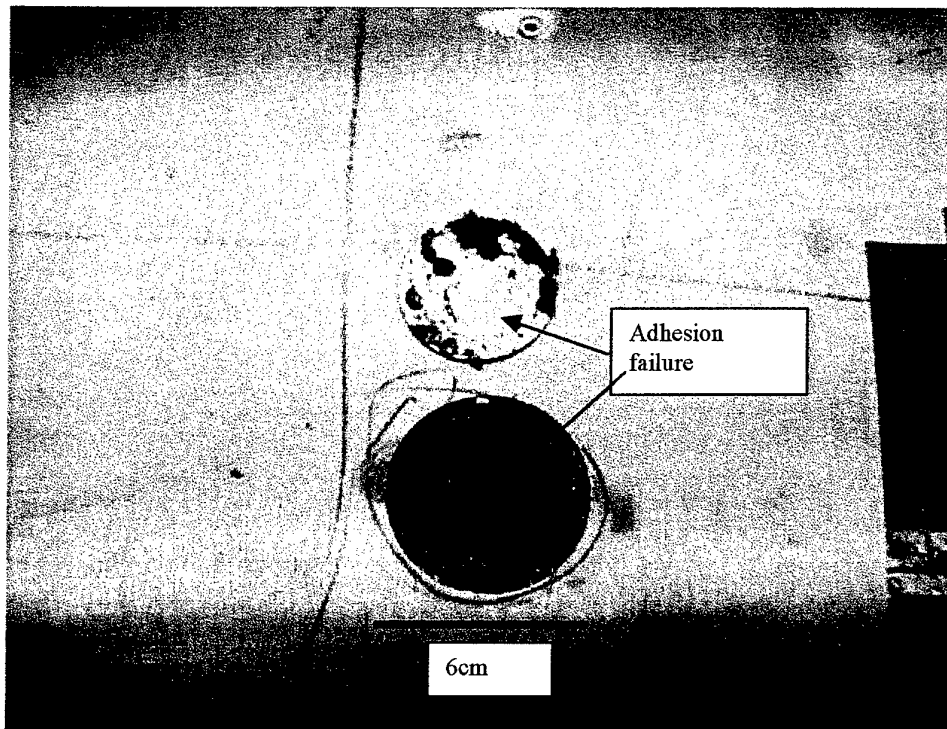
Figure 8.0 Adhesion failure surrounding an injection repair

regions around an injection repair have experienced obvious environmental degradation. In Figure 8 adhesion failure between the core and skin has occurred around an injection repair. In Figure 9.0 the adhesive-core fillet bonds have failed over an extensive area around the injection repair site as a result of penetration of water through the injection repair between the adhesive and core bond.

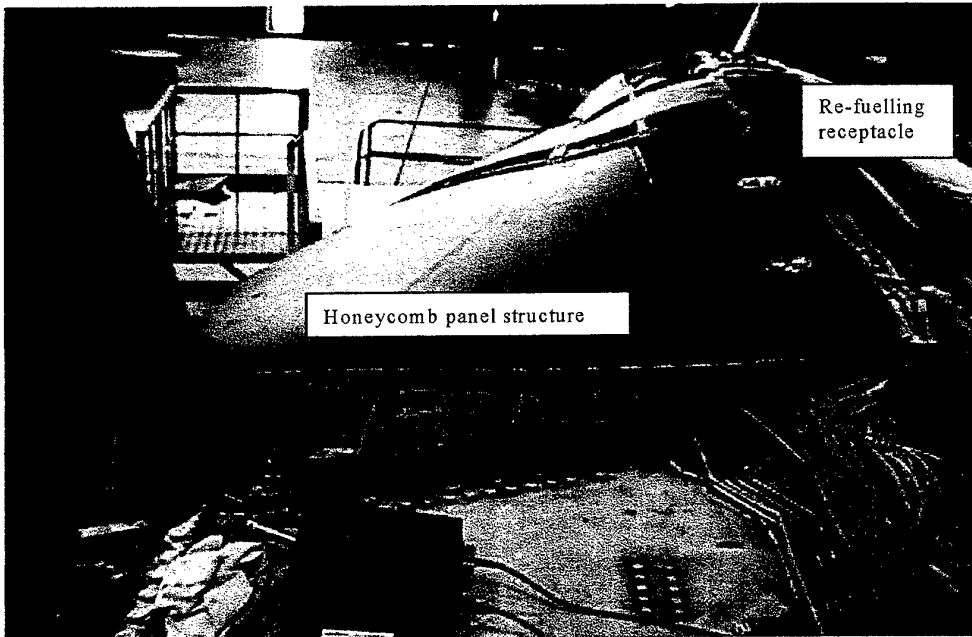
Figure 10 shows a region of the F-111 where honeycomb panel damage has a high probability of occurring. The large panels in the vicinity of the mid-air re-fuelling pod often will experience damage as the re-fuelling arm approaches the aircraft. These panels are riveted in place and require in-situ repair. Attempting to repair large panel areas has the problem of designing repairs outside repair manual specification together with the problem of moisture removal. Large repairs in-situ will also encounter difficulties in distributing a uniform heat over the entire repair region due to heat-sinks in the structure. Figure 11 also shows a difficult to access region of the F-111 weapons bay where a repair has to be undertaken. This is also a region where panel replacement would not be a viable option.

Figure 10. The large honeycomb panels in the vicinity of the re-fuelling area on top of the F-111. These panels must be repaired in situ and are susceptible to damage during the mid-air re-fuelling procedure.

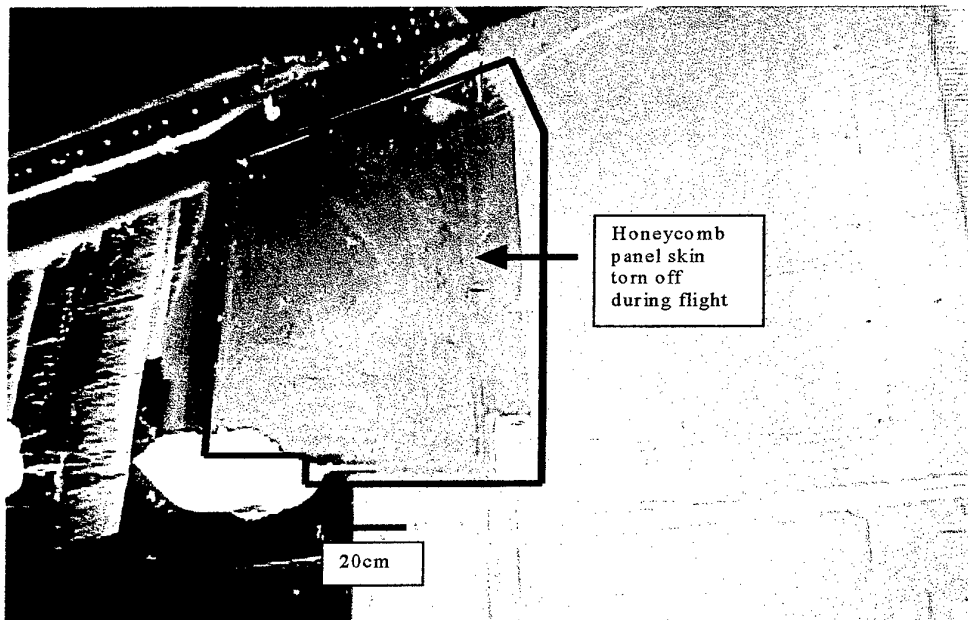
Figure 13 The exterior skin of a honeycomb panel that was removed during flight. The scale marker indicates the size of the panel. The location is just forward of the engine air-intake.

Here, the exterior skin from a large honeycomb panel was torn off the aircraft during flight just forward of the engine intake. Whilst it is unlikely that the skin would have entered the engine it would not have been impossible for some parts of the panel to have been sucked through the air-intake and cause significant engine damage. Clearly, not dealing with the problems of honeycomb panel structural integrity has the potential to lead to serious damage to the aircraft structure during flight and in a worse case scenario to loss of the aircraft.

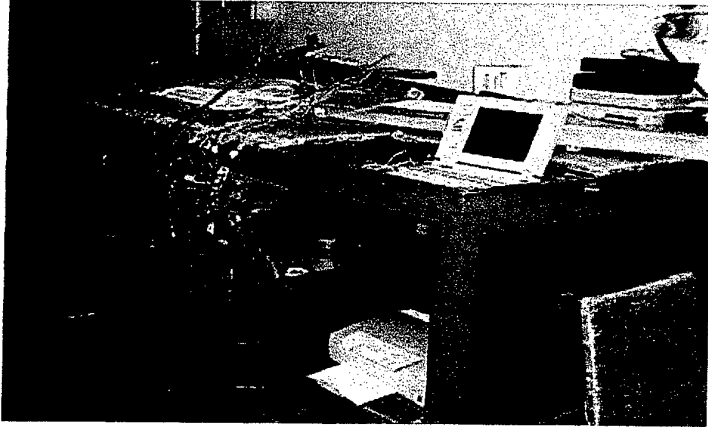
Figure A-2 Moisture evacuation of the repair area using the vacuum bag, heater blanket arrangement, using a hot-bonder unit HBC-43 from Novatech®.

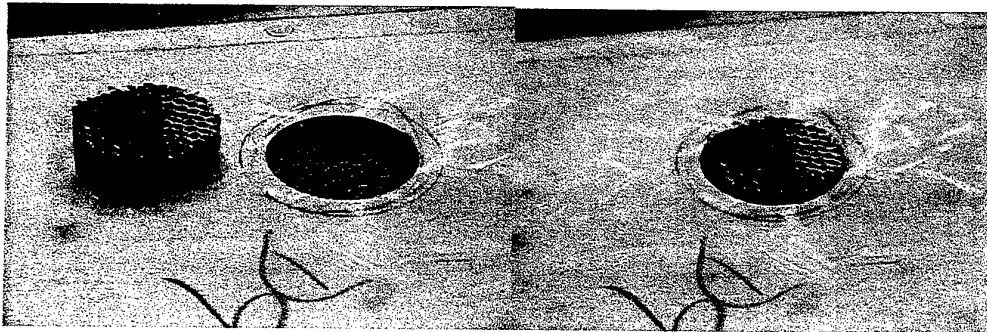
Figure A-3 The core plug insert used to repair the routed core

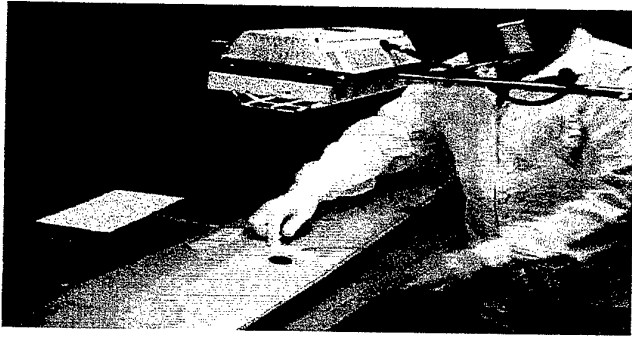
Figure A-4 Infrared heating of core after MEK flush.

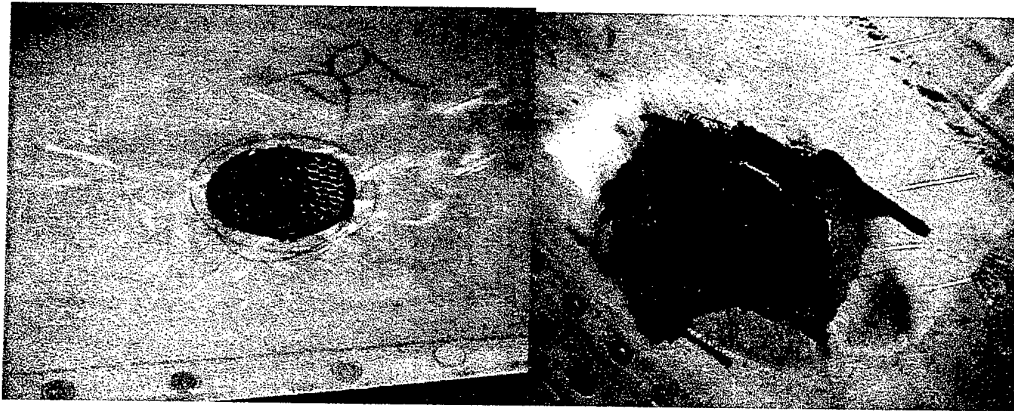
Figure A-6 The two pictures indicate that the plug bonded in position after the initial adhesive curing step. Note in the left-hand picture the foaming adhesive has not expanded correctly and voids exist between the plug and routed core. In the right hand side picture the foaming adhesive has expanded correctly. The foaming adhesive came from the same batch.

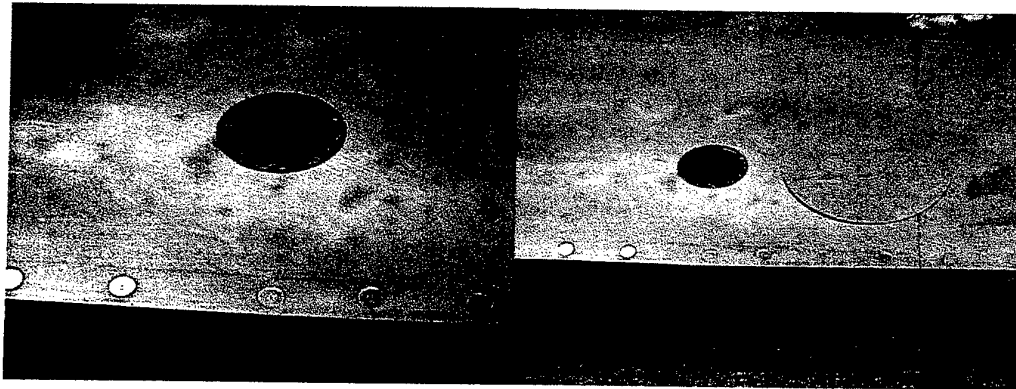
Figure A-7 The plug is sanded back to flush with the skin level and a metallic patch is applied using FM-300 film adhesive.
